Operating Experience Weekly Summary 97-27

June 27 through July 3, 1997

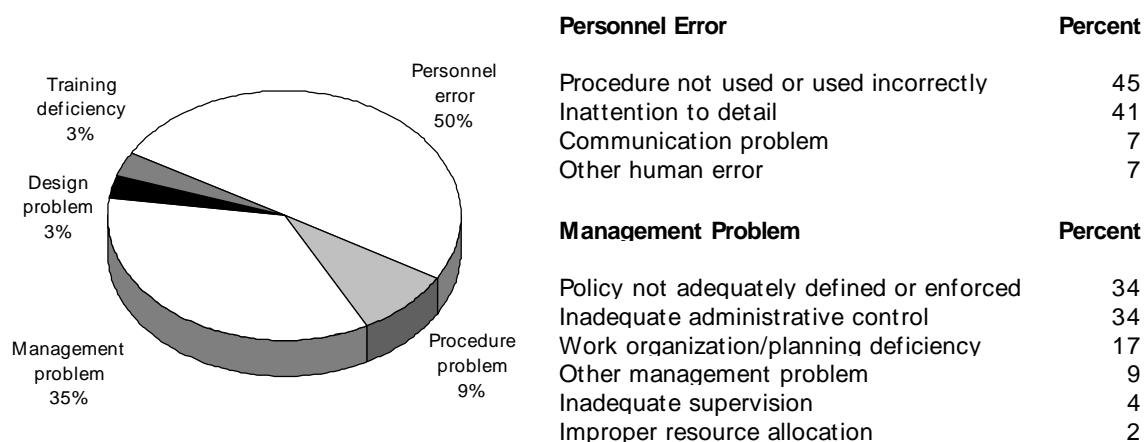
Figure 1-1. Distribution of Root Causes for Violation/Inadequate Procedures¹

Operating Experience Analysis and Feedback (OEAF) engineers reviewed the Occurrence Reporting and Processing System (ORPS) database for reports involving procedure violations or inadequate procedures and found 630 occurrences. Figure 1-1 shows the distribution of root causes reported by facility managers for these events. Personnel error represented 50 percent of the root causes and management problems, 35 percent. Procedure not used or used incorrectly accounted for 45 percent of the personnel errors and inadequate administrative control and policy not adequately defined or enforced each accounted for 34 percent of the management problems.

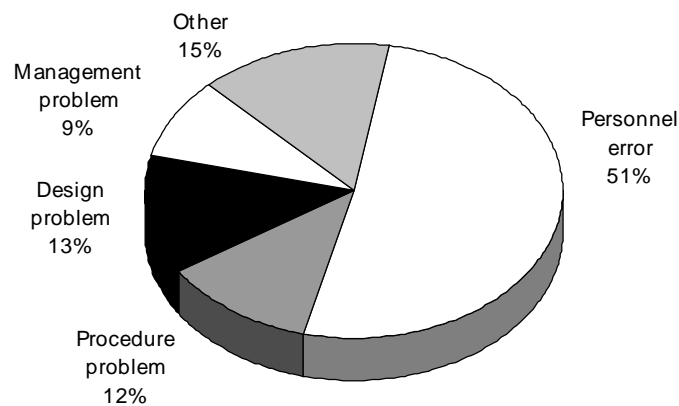
Figure 2-1. Distribution of Direct Causes for Disabled Alarms¹

Operating Experience Analysis and Feedback (OEAF) engineers reviewed the Occurrence Reporting and Processing System (ORPS) database for reports involving deactivated or disabled alarms that were not caused by an equipment or material problem and found 300 occurrences. Figure 2-1 shows the distribution of direct causes reported by facility managers DOE-wide for these events. Personnel error represented 51 percent of the direct causes. Inattention to detail accounted for 44 percent of the personnel errors, and procedure not used or used incorrectly accounted for an additional 29 percent of the personnel errors.

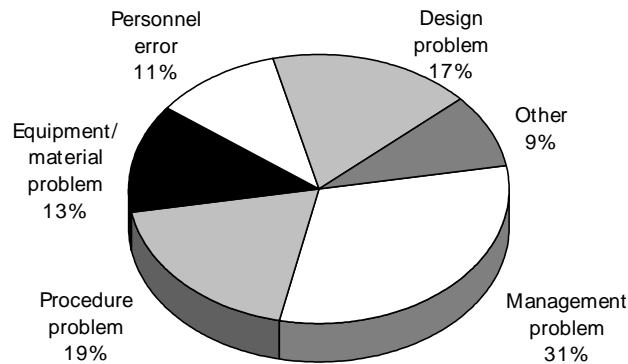
Figure 3-1. Root Causes for Radionuclide Releases DOE-Wide¹

releases and 81 involved gaseous and airborne releases. A search for radionuclide releases through a cooling tower or a ventilation stack resulted in 54 occurrences. Figure 3-1 shows the distribution of root causes reported by facility managers DOE-wide for these events. Design problems accounted for 17 percent of the root causes.
